Performance evaluation of a transmission tower by substructure test

In this paper, a half-scaled substructure test was performed to evaluate the failure mode of an existing transmission tower subjected to wind load. A loading scheme was devised to reproduce the dead and wind loads acting on the prototype transmission tower. The load was enforced on the model structure using two actuators and a triangular jig mounted on the reduced model. Preliminary numerical analysis was carried out to evaluate the stability and member force of the specimen for the design load. When the substructured transmission tower was loaded by 270% of its maximum allowable buckling load, local buckling occurred in joints of leg members with weak constraints. From the experimental results, such as load–displacement curves, displacements, and strains of members, it was concluded that the local buckling was due to the additional eccentric force caused by unbalanced deformation of the specimen.

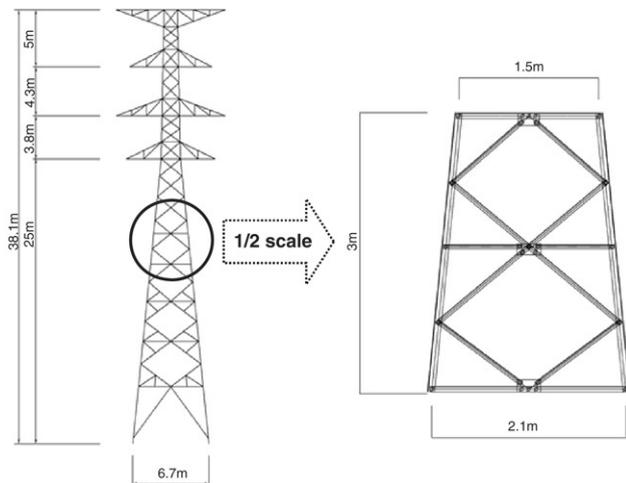
Fig. 1. A prototype transmission tower and a half scaled sub-assembly test model.

A 154 kV B2-type transmission tower of height 38.1 m illustrated in Fig. 1 was chosen as a prototype structure for experiment. In both sides of the tower 300 m-long electric wires are connected. For experiment two units in the middle of the tower were modeled with a 1/2 scale in length. In this case the cross-sectional areas are reduced to 1/4 of those of the prototype structure. The height of the test specimen is 3 m, and the plan dimensions of the bottom and top of the specimen are 2 m × 2 m and 1.5 m × 1.5 m, respectively.

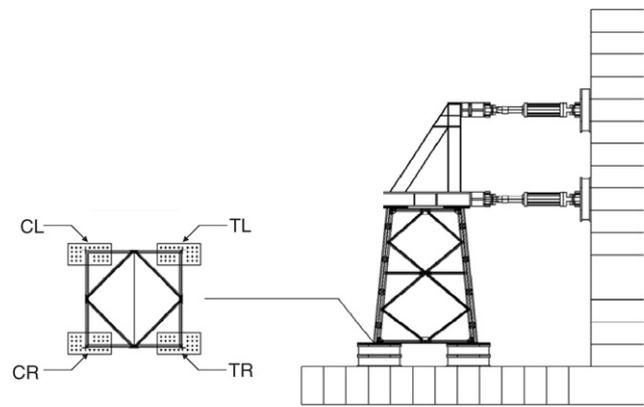
Fig. 2. Configuration of test model structure and actuators.

Generally a loading test of full-scale transmission towers uses a wire connected to each loading point. But, in this study, two hydraulic actuators were used to apply desired loading on the specimen as shown in Fig. 2. The actuators impose both bending moment and lateral shear force to simulate the loads transmitted from the removed upper substructure through a triangular jig. This test setup has advantage in that local failure modes can be more thoroughly observed. The actuators with the capacity of 140 MN and 90 MN were placed at the height of 5 m and 3 m from the ground, respectively. The height of the specimen is 3 m, and the maximum height that an actuator can be placed in the laboratory is 5 m. Therefore a 2 m moment arm is available to impose bending moment on the specimen. However the moment arm required to meet the similarity law is approximately 8 m. To provide the specimen with equivalent bending moment the lateral force from the actuator should be increased significantly. This, however, results in unnecessarily high shear force acting on the structure. To reduce the shear force down to the design load level, another actuator was installed at the height of 3 m to apply load in the reverse direction. To carry out the experiment by displacement control, the displacement under design load was computed by numerical analysis, and the displacement was increased until failure of the structure. The test setup is depicted in Fig. 2.

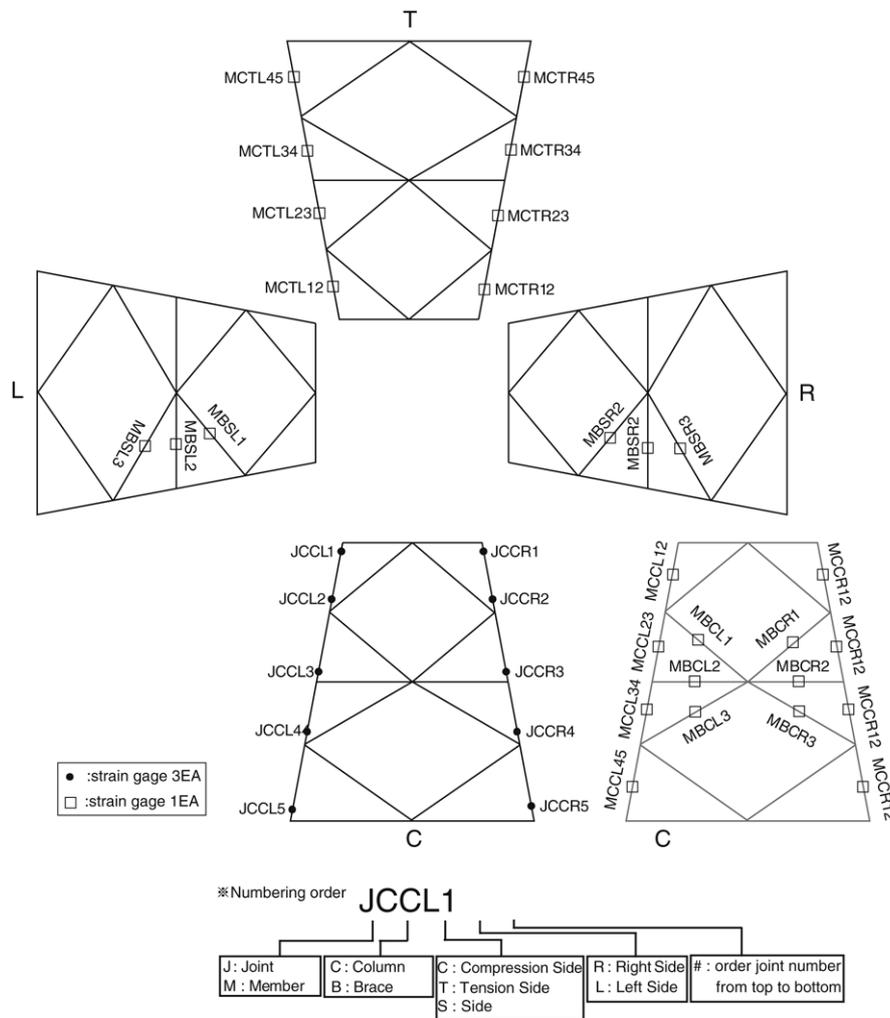
Fig. 3. Naming and location of strain gauges.

The locations of strain gauges and the naming of elements and joints are shown in Fig. 3. The name of strain gauges located between the joints starts from M and the name of those placed near the joints starts from J. As the number of channels in the data logger is only 60 and there are many structural members, strain gauges were installed in limited locations. The expected failure mode of a transmission tower subjected to an overturning moment is the buckling of the compression members. According

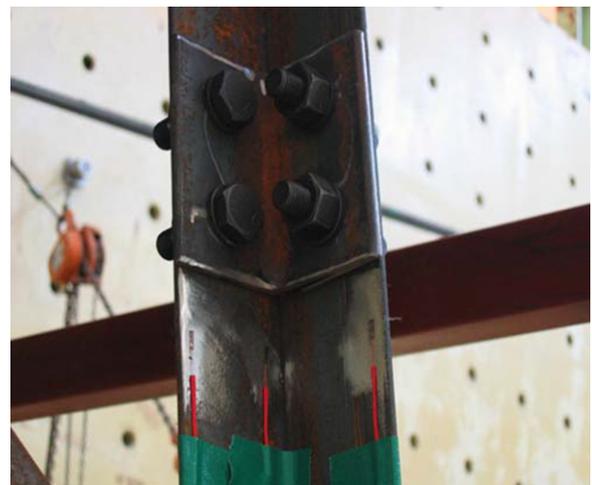
Fig. 4. Placement of strain gauges near a joint of a leg member.

Fig. 16 shows the strain of the left-hand-side leg members subjected to compression. As shown in Fig. 4 three strain gauges, named as ‘left’, ‘corner’, and ‘right’ viewed, were installed at one place. At joints JCCL1, JCCL2, and JCCL3 the strains recorded by the three strain gauges increased linearly until the top

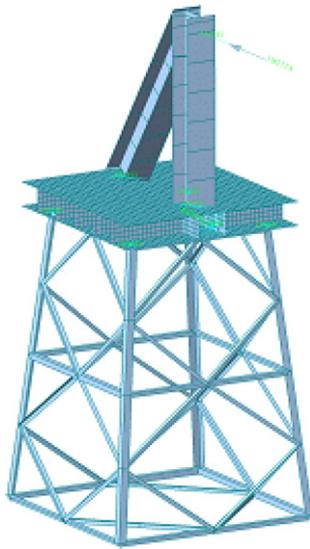
Fig. 6. Finite element modeling of the transmission tower test specimen (MIDAS Civil).

The triangular upper part of the jig was modeled by beam elements and the remaining lower part was modeled by shell elements. The beam and the shell elements were connected by rigid links. The numerical modeling and analysis of the model structure were carried out using the finite element analysis program package MIDAS-Civil [8]. Fig. 6 shows the analysis model of the test

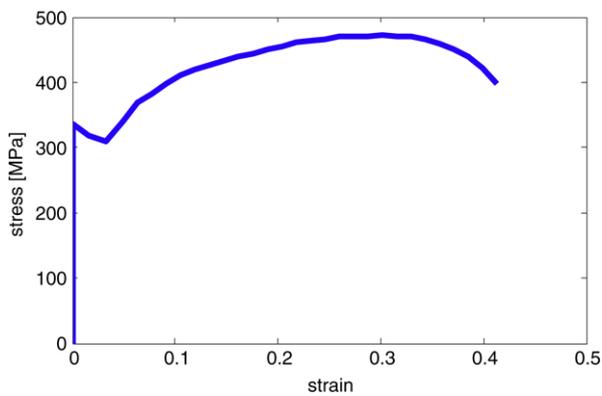
Fig. 7. Stress-strain curve of the steel angle (coupon test result).

Nonlinear analysis of the specimen was carried out using the finite element analysis program ANSYS Structural Utility. Nonlinear material property was found from the coupon test result shown in Fig. 7. Fig. 8 shows the nonlinear analysis model of the test specimen. The triangular upper part of the jig and angle members were modeled by BEAM 188. The plate steel part of the jig was considered as a rigid link since it shows rigid body motion during the experiment. The bolt connection was modeled by COMBIN7 to consider applied torque of the bolt. COMBIN7 is a 3-D pin joint which may be used to connect two or more parts of the model at a common point. Capabilities of this element include joint flexibility (or stiffness), friction, damping, and certain control features. An important feature of this element is a large deflection capability in which a local coordinate system is fixed to and moves with the joint. Fig. 9 shows the stress distribution and deformation shape of a test specimen as a result of the nonlinear analysis.

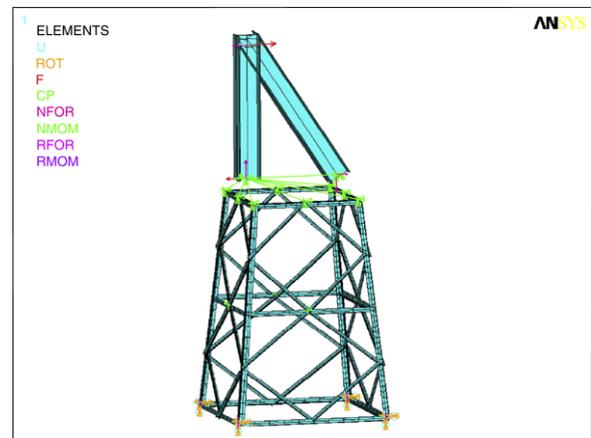
Fig. 8. The nonlinear analysis model of the transmission tower test specimen (ANSYS Structural U).

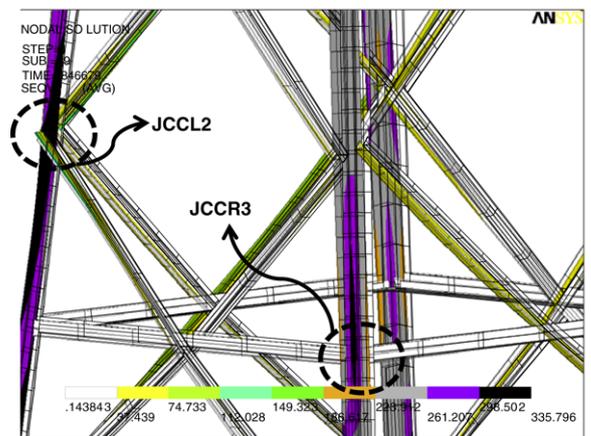
Fig. 9. Von Mises stress and deformation of nonlinear analysis results.

It is observed that the yield stress occurred in the “JCCL2” and “JCCR3”. This local buckling in both “JCCL2” and “JCCR3” coincides with the experimental results shown in Fig. 10. Accordingly, the nonlinear analysis results performed in this study can estimate the experimental results.

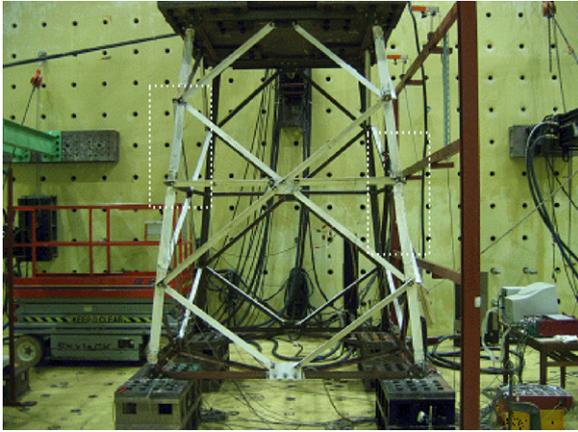
Fig. 10. Photograph of the specimen after loading is over.

Fig. 10 shows the side view of the specimen after loading was over. It can be observed that global buckling did not occur in any member under compression. However it can be noticed in Fig. 11 that the column was twisted due to local buckling. The parts in which local buckling occurred are shown in Fig. 10 enclosed in the dotted rectangles. The joint of the column which experienced local buckling and is shown in the right-hand-side of Fig. 10 is depicted in Fig. 11.

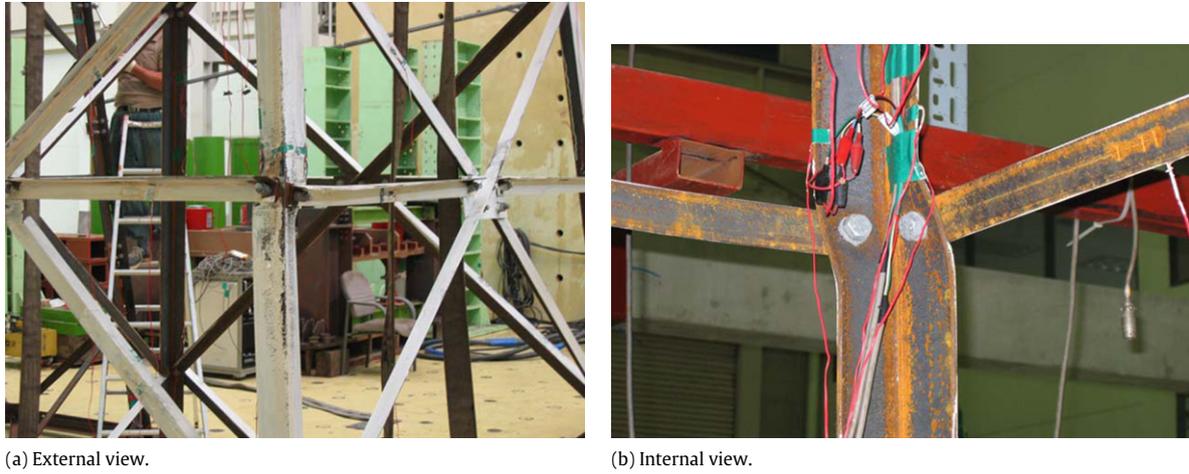
Fig. 11. Deformation of the leg member near the joint JCCR3.

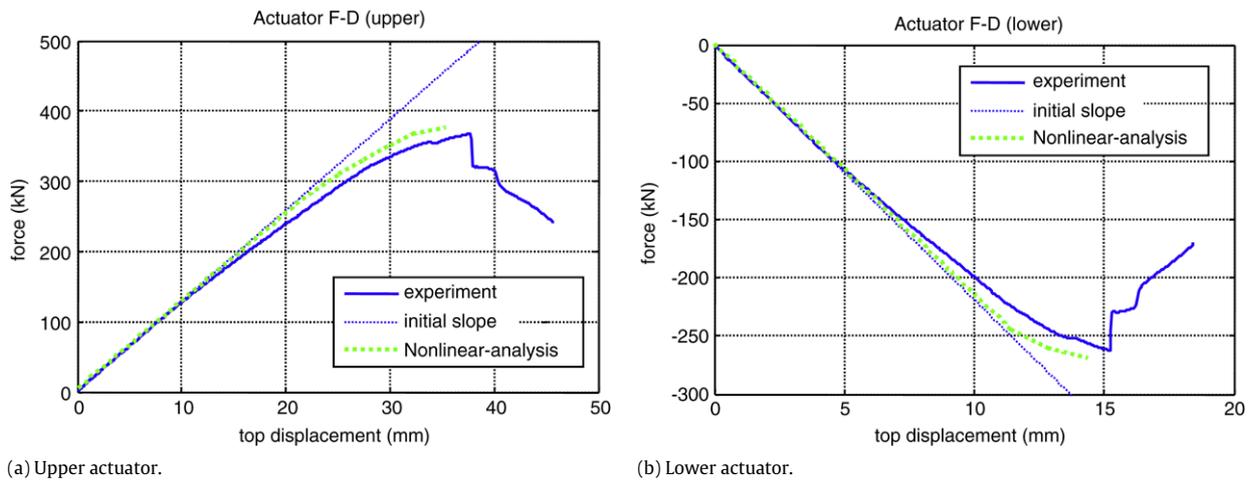
Fig. 12. Load–displacement curves of the test specimen at the location of actuators.

It was observed from the load–displacement curves that the lateral displacement obtained from experiment was similar to the displacement computed from nonlinear analysis. Fig. 12 shows the load–displacement curves recorded by the two actuators.

The yield or fracture of members can be noticed by the decrease of stiffness in the load–displacement curves. It can be observed that the slopes of the curves decrease gradually as the displacement of the lower actuator exceeds about 6 mm. Considering that the decrease of stiffness occurred before member yield strain was reached, this may have been caused by the slip in bolted connections.

observed in the load–displacement curves shown in Fig. 12 was caused by local buckling of the leg members MCCL23. On the other hand, the displacement measured by LVDT4 located at the lower part of the leg member MCCR23 increased rapidly when the displacement at the loading direction reached 15.1 mm. This indicates that the second rapid change in stiffness shown in Fig. 12 was due to the local buckling of the leg member MCCR23.

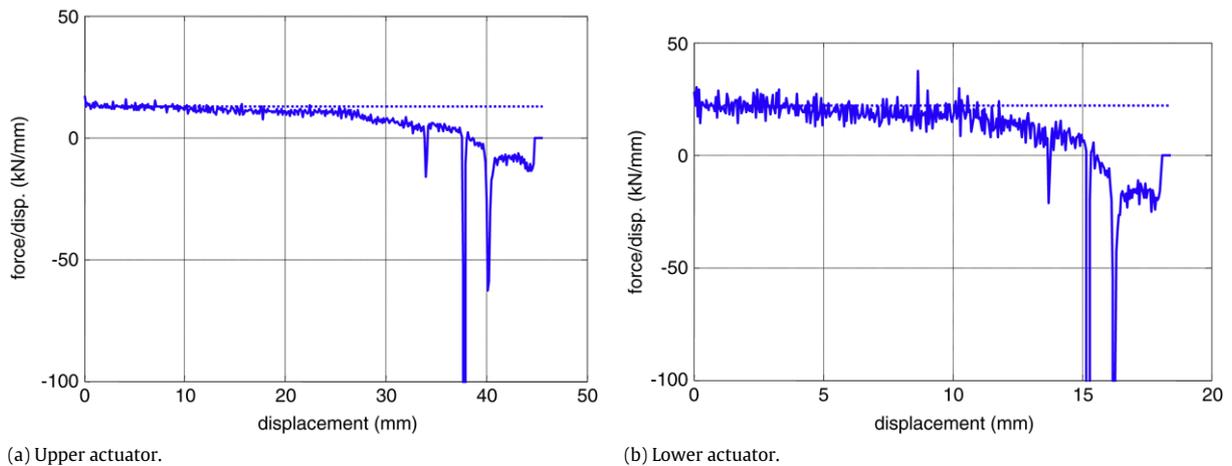
Fig. 13. Slope of the load–displacement curves of the test specimen measured by actuators.

Fig. 13 presents the slopes of the load–displacement curves recorded by the actuators. It can be observed that rapid change in slope occurred when the displacement of the lower actuator reached 13.5 mm, 15.2 mm, and 16 mm. The change in slope was accompanied by drastic reduction and subsequent recovery followed by a gradual decrease in slope. This phenomenon is considered to be associated with the buckling of a member and following redistribution of member forces. As will be stated later, the points of stiffness reduction match well with those of rapid change in strain and member forces. It also can be observed that stiffness decreased minutely before abrupt change in stiffness, which becomes noticeable after the actuator displacement exceeds 26 mm and 11 mm. This is considered to have been caused by yielding of members rather than bolt slip.

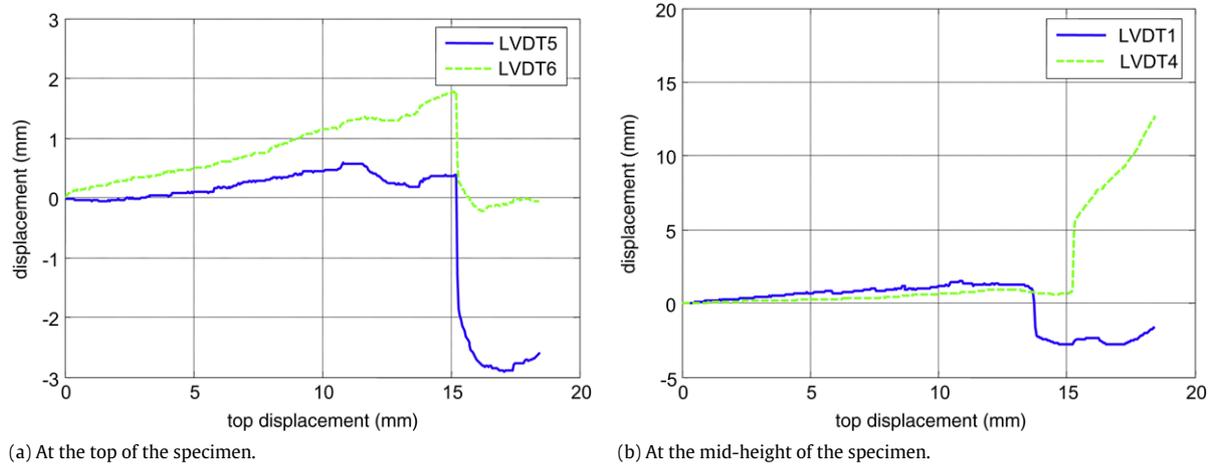
Fig. 14. Lateral displacements perpendicular to the loading direction.

Fig. 14 shows the horizontal displacement of the specimen perpendicular to the loading direction, where the horizontal axis represents the corresponding displacement in the loading direction. The large difference in the data recorded in the two LVDT's mounted on the upper part of the specimen implies that the specimen was twisted during the experiment. The difference in displacement was transformed to the twisting angle and is presented in Fig. 15. As the lateral displacement along the loading direction exceeds 10 mm, the rate of change in twisting angle increases, which corresponds to the point where the slope of the load–displacement curve shown in Fig. 13 decreases significantly. Also, the twisting angles suddenly changed when the displacement in the loading direction reached 15.1 mm, which corresponds with the point that actuator load dropped rapidly as shown in Fig. 13. The maximum rotation, however, turned out to be approximately 0.11° and the effect of torsion is not considered to be significant. It can be seen in Fig. 14(a) that the displacement measured by the LVDT1 located at the lower part of the leg member MCCL23, which experienced local buckling, changed significantly when the top displacement along the loading direction reached 13.5 mm. Therefore it can be concluded that the abrupt change in stiffness

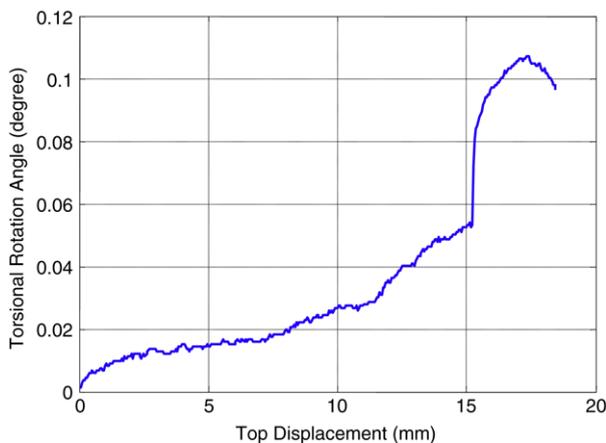
Fig. 15. Torsional rotation angle at the top of the specimen.

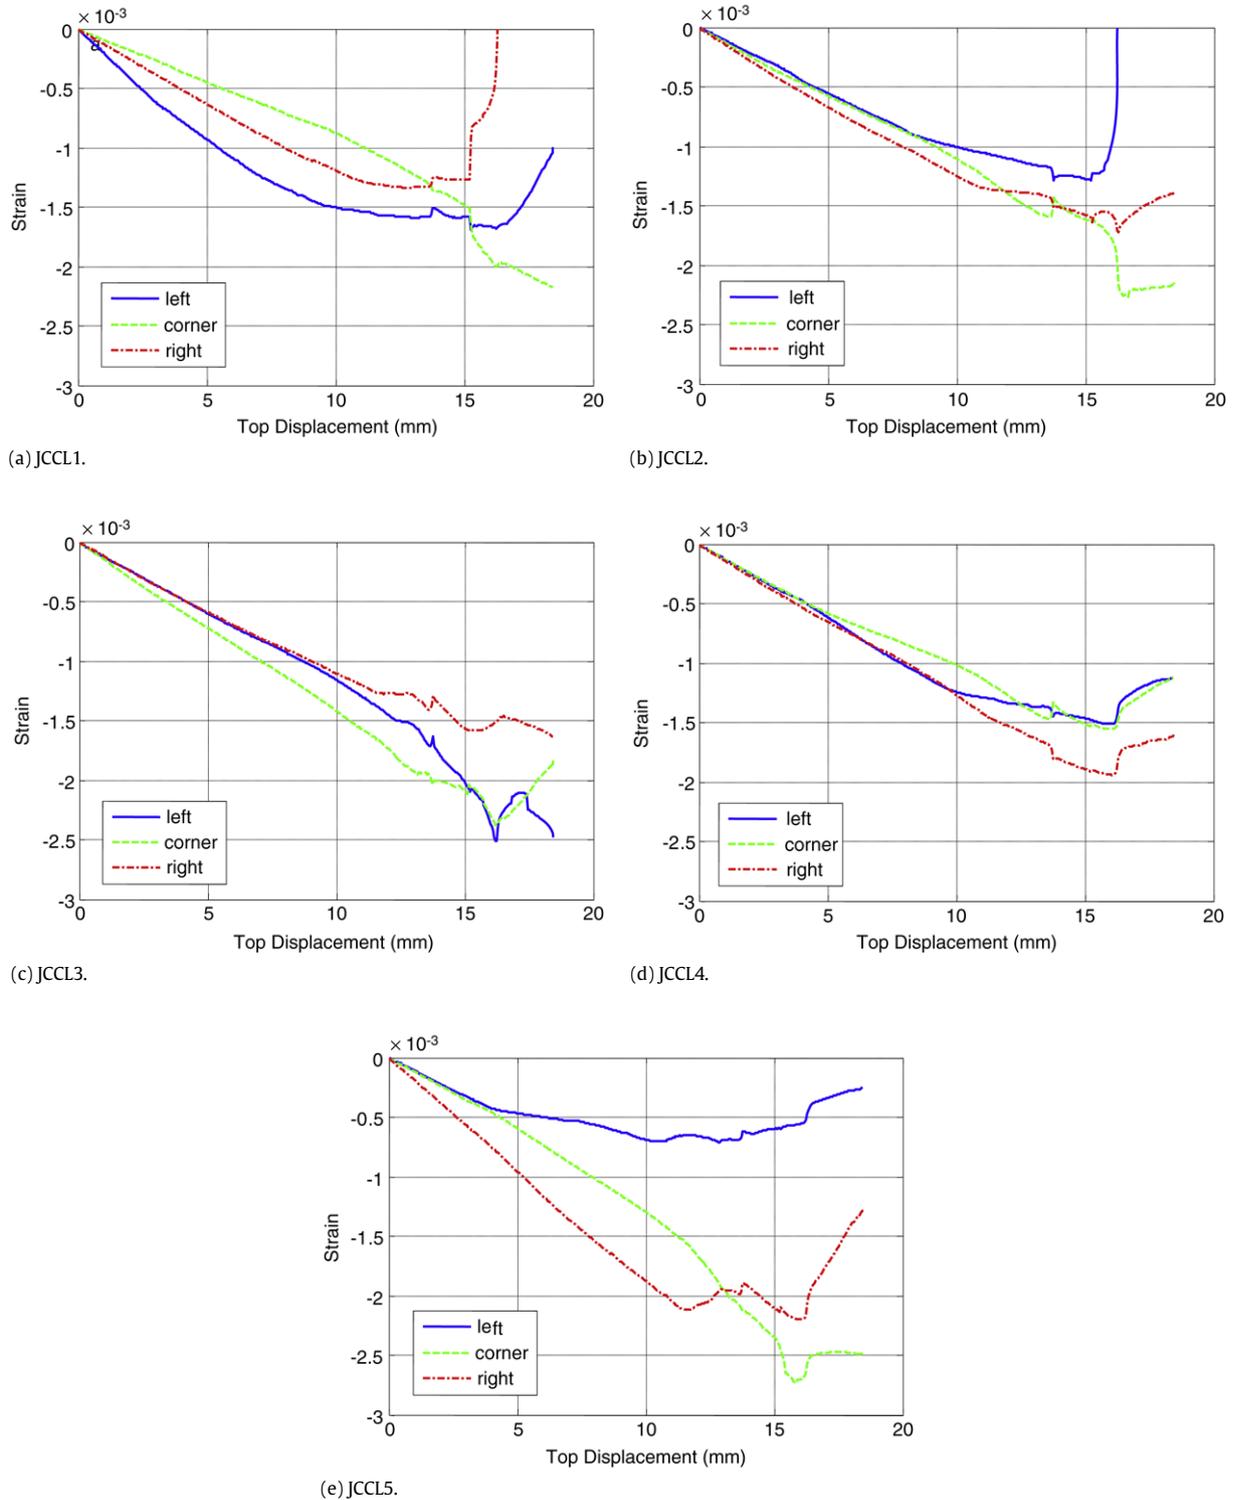
Fig. 16. Strain of the left leg member subjected to compression.

displacement reached 10 mm. Then local buckling occurred and the strains became highly nonlinear. At joints JCCL4 and JCCL5 such phenomenon occurred in the earlier stage, at around the top displacement of 5 mm. This is considered to have been caused by bolt slip or local yielding around the bolt holes. Based on the load–displacement curves it was observed that at the top displacement of about 13.5 mm the first local buckling occurred at the left-hand-side leg member subjected to compression. However, at this moment the strains did not change significantly, probably because the distance between the location of the strain gauges and the point of local buckling was far enough. After the top displacement exceeded 15.1 mm, local buckling occurred at the right-hand-side leg member, which caused a large bending moment at the left-hand-side joints (JCCL11, JCCL12) and significant change in strains.

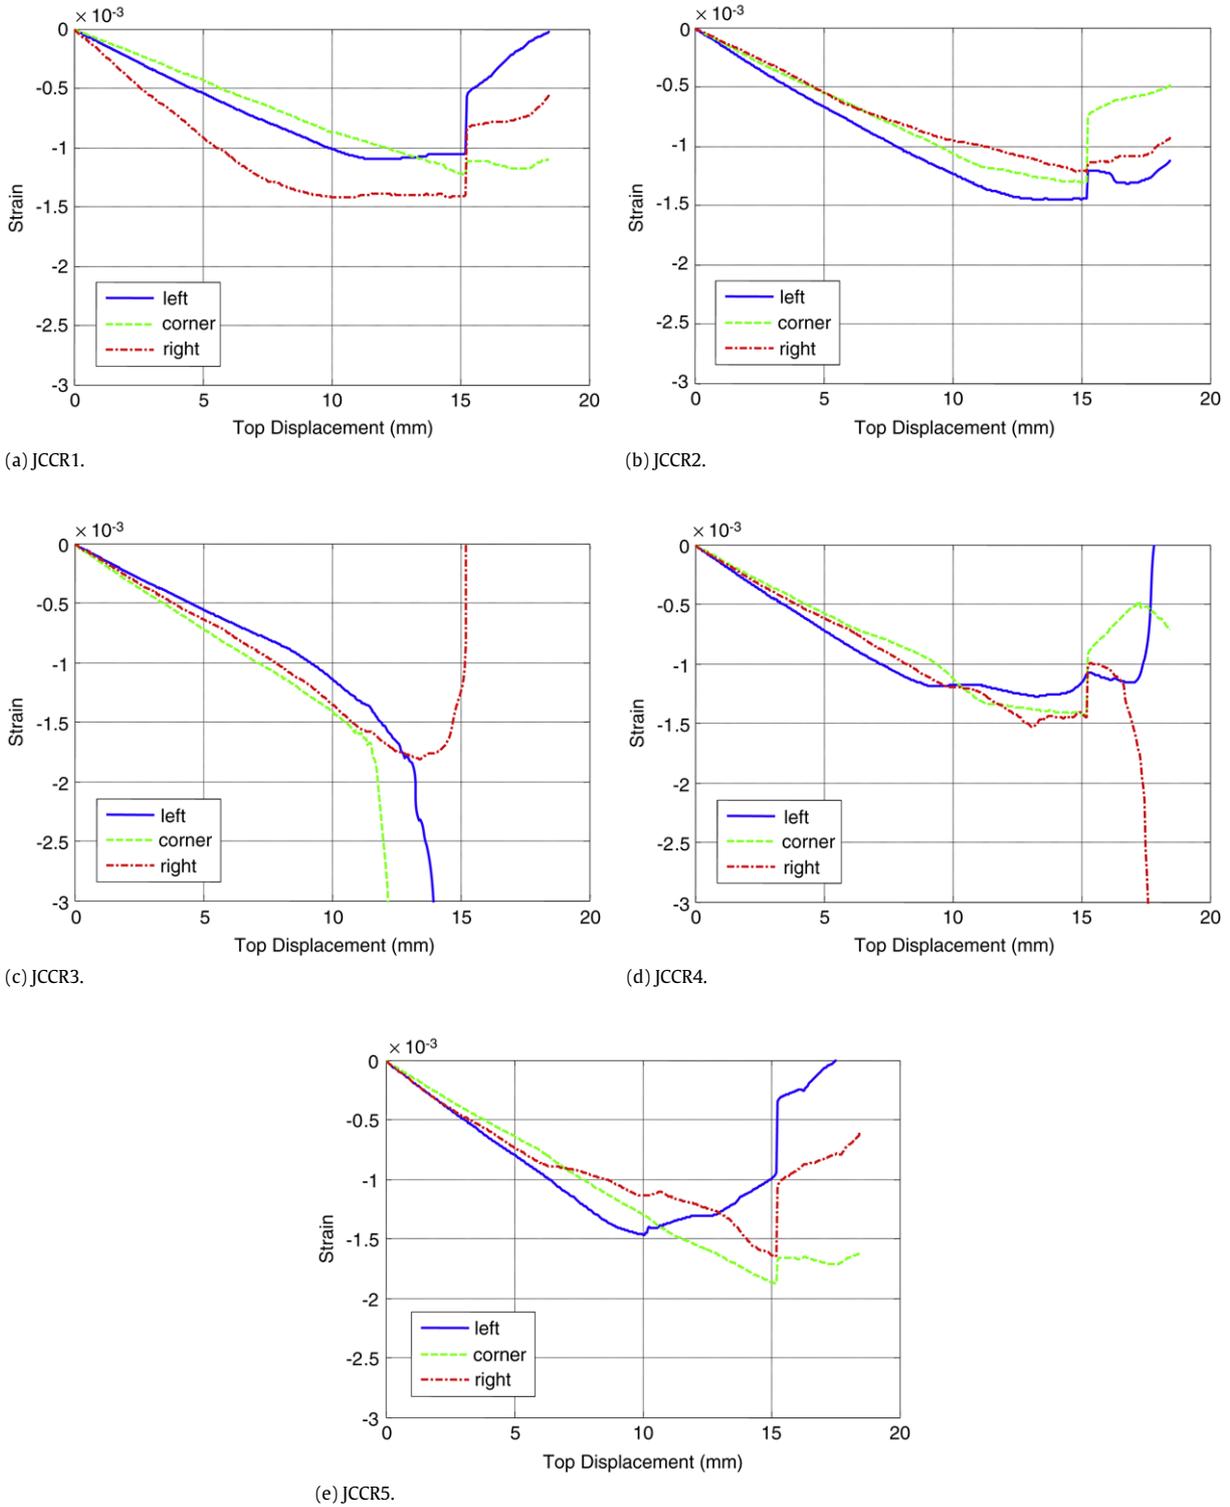
Fig. 17. Strain at joints of the right leg member subjected to compression.

Fig. 17 shows the strains measured at the right-hand-side leg members subjected to compression. As was observed in the left-hand-side leg members, the strains increased linearly. However after the top displacement exceeded about 7 mm and local buckling occurred at the joints, the measured strains changed rapidly. It also can be observed that at joints JCCR3 and JCCR4, in which local buckling occurred, significant amount of strains were measured. However at joints JCCR1, JCCR2, and JCCR5, the measured strains did not increase further because the load carrying capability of the member MCCR34 decreased after local buckling. The compressive strains measured by the 'left' and 'corner' gauges placed near the joint JCCR3 increased significantly due to the yielding of material, whereas in the 'right' gauge the compressive

strain changed to tensile strain due to bending deformation. On the other hand at joint JCCR4 the compressive strain of 'right' gauge increased rapidly and those of the 'left' and 'corner' gauges decreased significantly or even were reversed to tensile strains, which implies that bending and torsional deformation occurred. According to the displacement of the specimen in the transverse direction shown in Fig. 14(b), the first local buckling occurred at the left leg members. However before the local buckling occurred, when the top displacement reached approximately 12 mm, the strain in the 'corner' gauge at JCCR3 showed rapid increase. This seems to have been caused by yielding of the member considering the fact that no rapid variation was observed in the displacement recorded by LVDT4 placed in the middle of the right leg member.

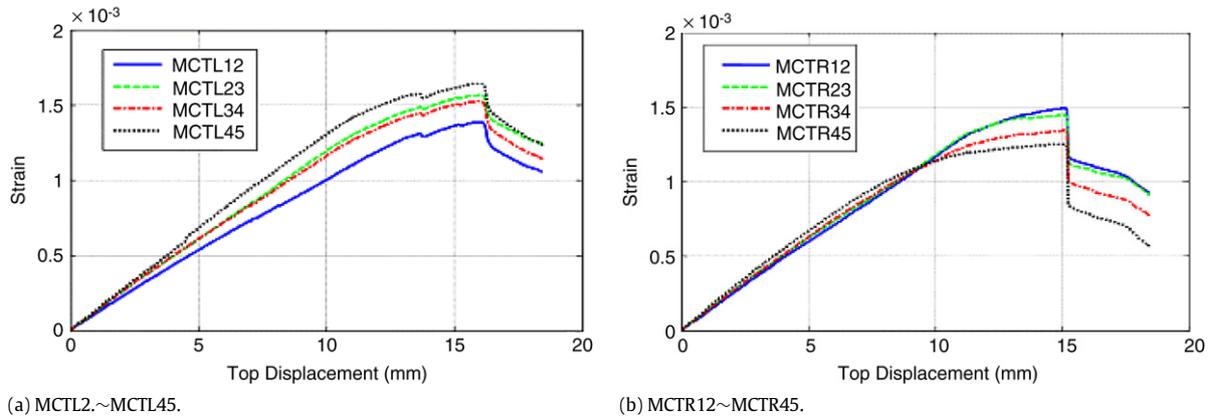
Fig. 18. Strain at various locations in members subjected to tension.

Fig. 18 shows the strains of the leg members subjected to tension. Even though the strains far exceeded the yield strain of SS400 steel, 0.001190, the members were considered to have remained elastic as no abrupt changes were observed in the measured strain data. Fig. 18(a) shows that the strains obtained from the 'left' and 'right' strain gauges attached to the left leg members were similar to each other. On the other hand rates of increase in the strains obtained from both ends of the right leg members were reversed after the top displacement exceeded 9 mm as can be seen in Fig. 18(b). This showed that bolt slip occurred at the right leg members.

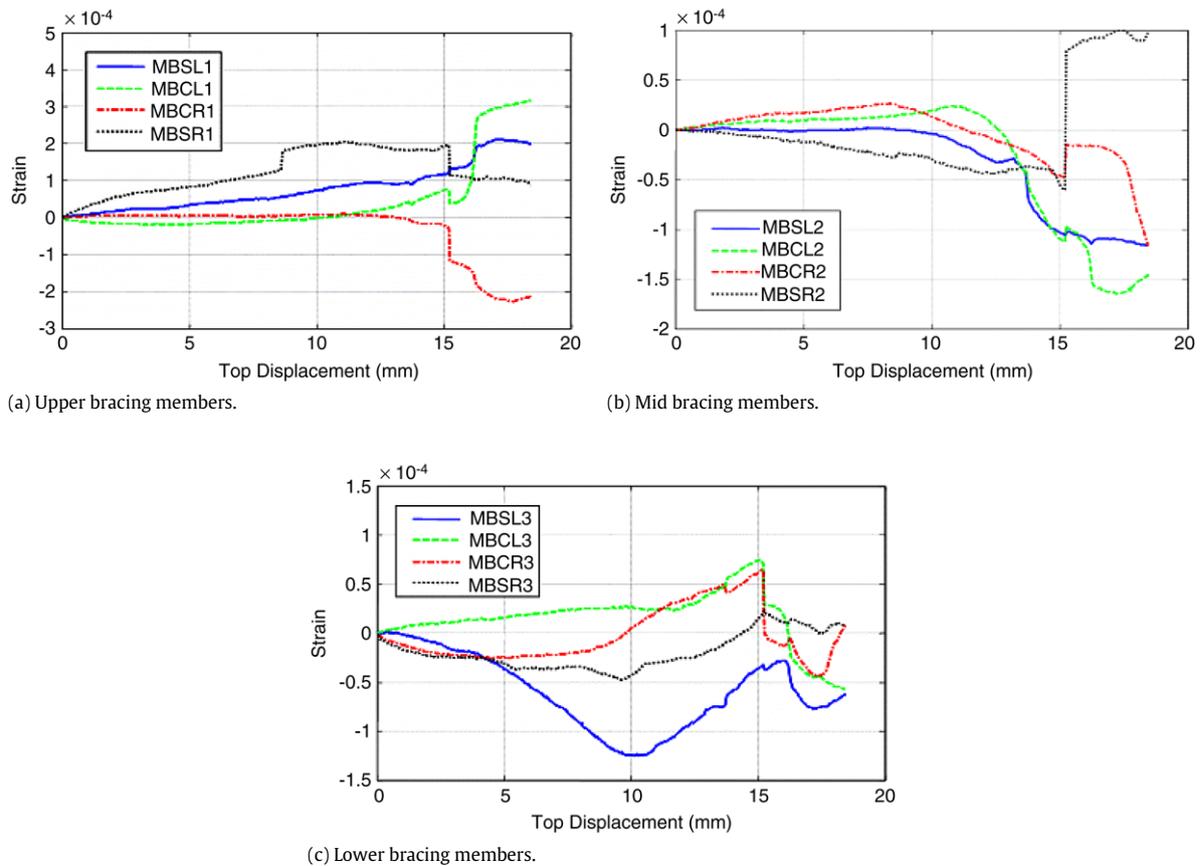
Fig. 19. Strain of bracing members.

Fig. 19 depicts the strains of the bracing members, and the strains obtained from experiment and nonlinear analyses were compared in Table 7. It can be observed, especially in the bracing member MBSL1, that as a result of bolt slip the strains did not increase linearly. The difference between the strains obtained from experiment and analysis is also considered to be originated from bolt slip. It also can be noticed that right after the first and the second local buckling in members and subsequent redistribution of member forces, the strains of bracing members changed significantly.
